PASSAIC RIVER BASIN

PINES LAKE DAM

PHASE I INSPECTION REPORT NATIONAL DAM SAFETY PROGRAM

NJ 00250

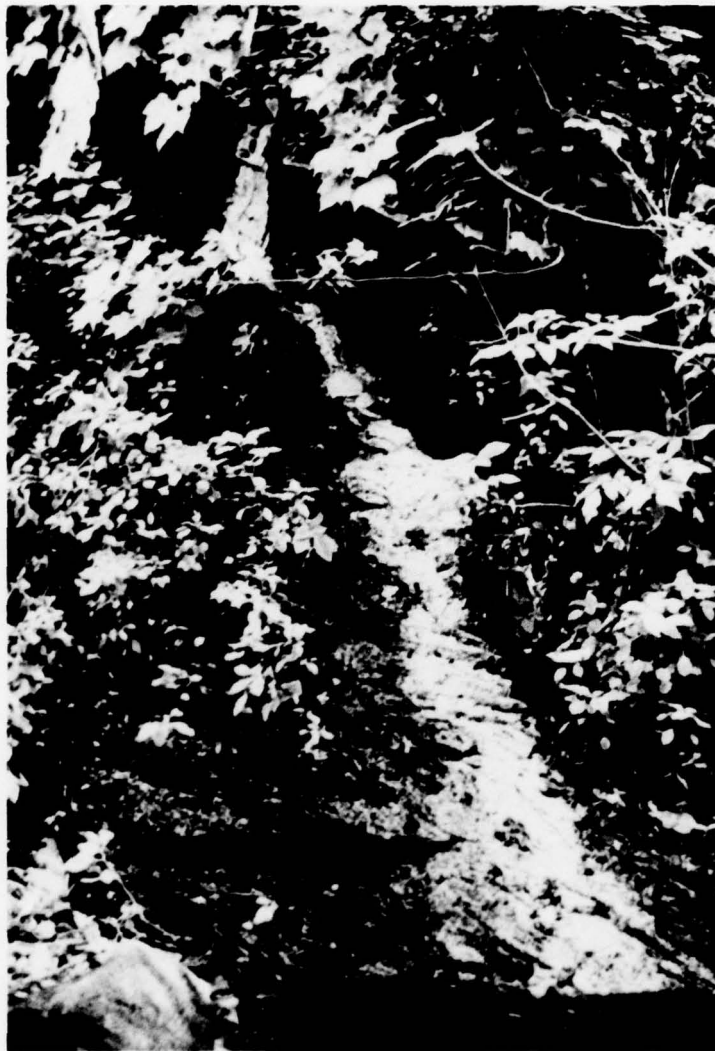
PHOTO 5

Seepage was observed near both rock abutments. It is believed that the seepage has been present for quite some time. The seepage at the right abutment was minimal flowing at approximately one g.p.m. This rock abutment had been grouted in 1961. The seepage at the left abutment was more significant with an approximate rate of about seven g.p.m., which was an increase over the estimated three g.p.m. observed in October 1976. The seepage was present at higher ground elevations, indicating flow from the reservoir as opposed to normal groundwater flow. The seepage was generally confined to the area just downstream of the dam.

Photo 5 - Close-Up of Seepage From Shale Bedrock Approximately 45 Feet Downstream From Left Abutment (Note Staining of the Bedrock Indicating Continuous Flow.) - 19 June 1978

- 1) Assess the seepage conditions of the abutments and valley bottom, particularly the left (east) abutment area.

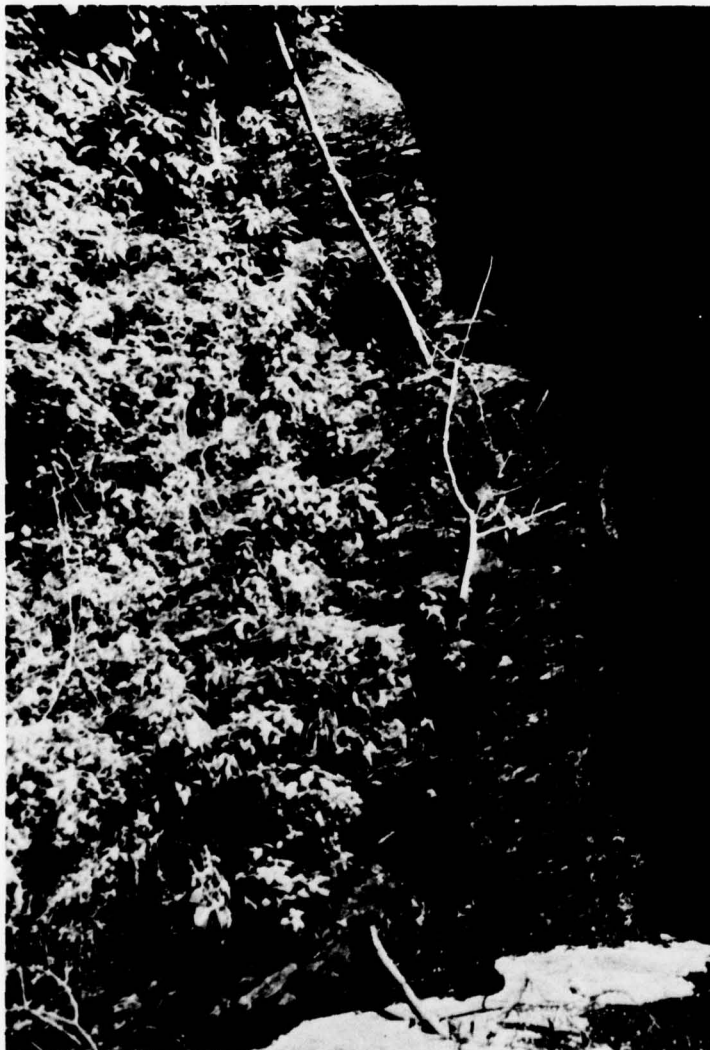
PHOTO 7

Photo 7 - View of Right Abutment Area at the Concrete-Shale Bedrock Junction at Front Face of the Dam (Note Crack in Gunite Surface and Slight Seepage From Bedrock.) - 19 June 1978

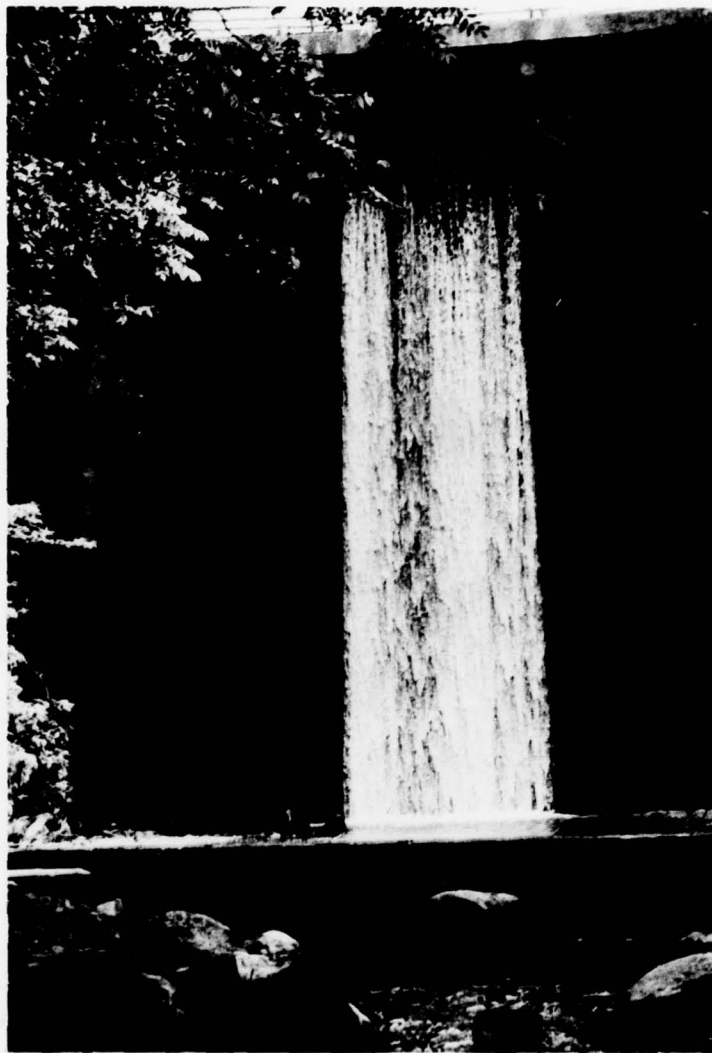
PHOTO 8

No gunite was noted to be present beneath the overflow spillway. There was evidence of minor spalling in the area.

Photo 8 - View of Spillway Showing spalling of Gunite Veneer - 19 June 1978
